Manassas City Public Schools

Schools Facility Plan 2020-2030

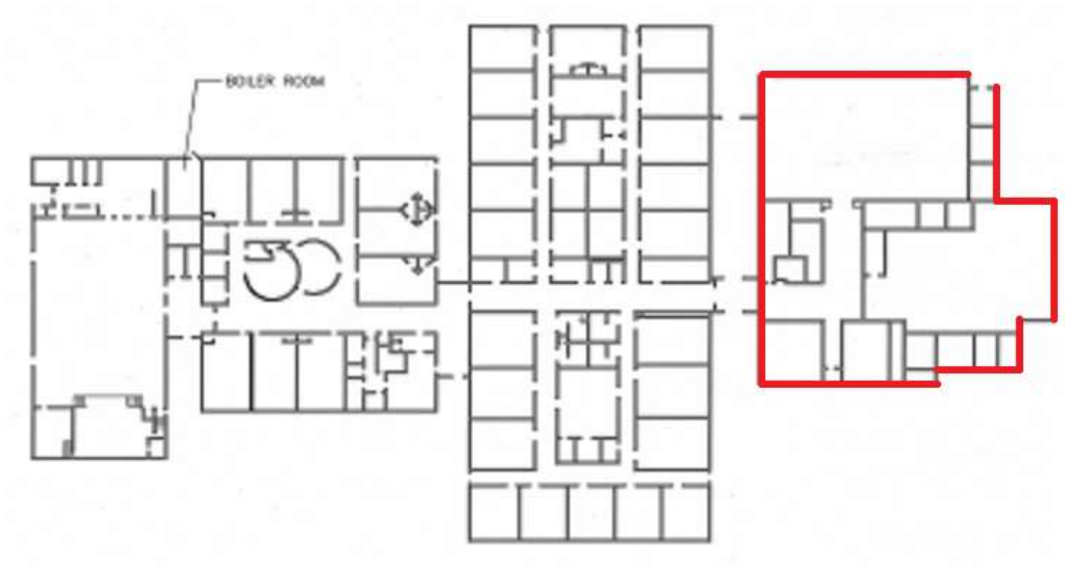
ROOF AND SIDING:

The school building has 2 roof types: flat rubber roof and metal. Plan for an addition, which is outlined in red, was completed in 2006 and executed in 2007. The addition and portable units (2664 sq. ft.) make the total area of the school 76,368 sq. ft. The main roof is 37 years old and has already passed its life span. The flat roof over the mechanical room was changed in 2011-12. The remaining flat roof was installed as a part of the construction in 2006-07. It is recommended that the main roof be replaced before 2020. The roof on the addition is good for the next 25 years. The metal roof is planned for replacement in 2016-2017 school year.

The gutters and downspouts were replaced and are in good condition.
